## Case Study: Vulcan Car Engine Refurbishment: Bringing a piece of British motoring heritage back to life

### Technologies used to reverse engineer the 1906 Vulcan Phaeton crankcase:

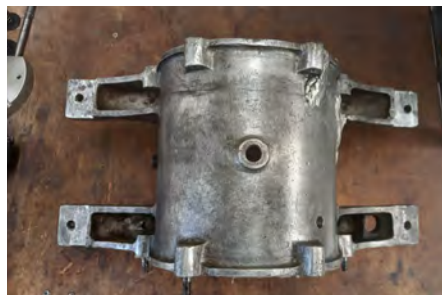
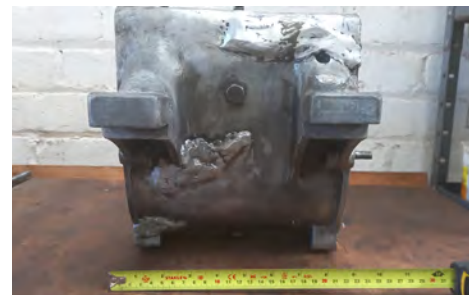
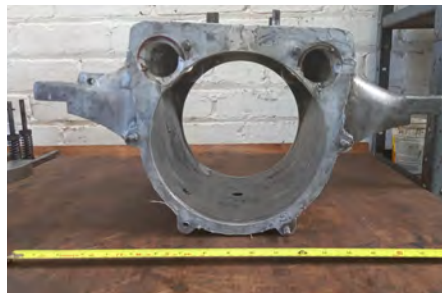
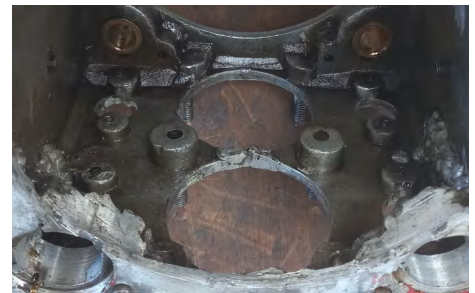
NovaCast was approached by a specialist engineering company to help with the refurbishment of a 1906 Vulcan Phaeton which had suffered a catastrophic engine failure at some time in its past. Not only had a conrod smashed through the crankcase but the resulting overloading of components had torn the front top half of the casing in the vertical and horizontal plane. To make matters worse, the subsequent welded repair had been done so badly that the casing was severely weakened, the inlet camshaft was out of parallel, the stud holes were compromised, and an engine mounting leg was distorted.

The original crankcase was distorted, cracked, and badly repaired.

It was obvious that the crankcase was so badly damaged and distorted that it would never function efficiently again, and the engine would need to be re-built using some new cast components. Clearly, with an engine of this age it would not be possible to buy replacement components, so NovaCast was approached to enquire about the possibility of reproducing the main crankcase using the existing one as a guide. As specialists in reverse-engineering, NovaCast was a good choice having extensive expertise in re-creating and improving existing cast components and fabricated assemblies.

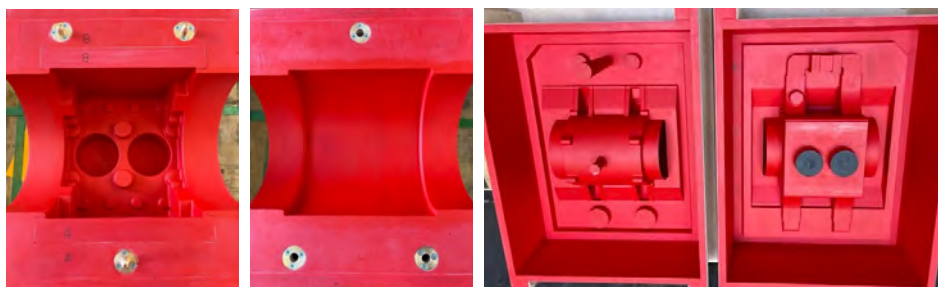
This crank case was to be sand cast in LM25 aluminium alloy that would then be heat treated to its TF state, then machined to the final tolerances. Step one was to run a simulation of the casting using InspireCast simulation software without any running method to determine areas where casting defects were likely to occur. Once these had been identified, multiple running method designs were tested using the simulation software until all potential casting defects identified on the original simulation had been eliminated. The optimum running method design was then used to specify the sand-casting pattern design.

New sand casting patterns were created for the crankcase

When the Patternmaker's shrinkage allowance and draft angles had been added to the design, along with the required machining allowances, the design was passed to the patternmaker. To mould the part, it was necessary to find ways to create the undercut feature in the crank case which the customer wanted to keep, so both the pattern and core box had to have a loose core to achieve this.

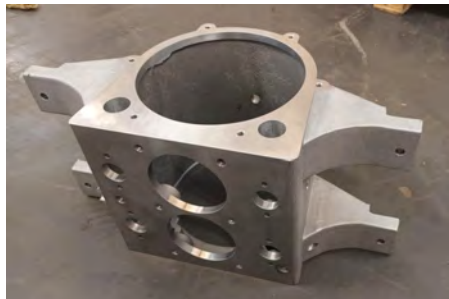
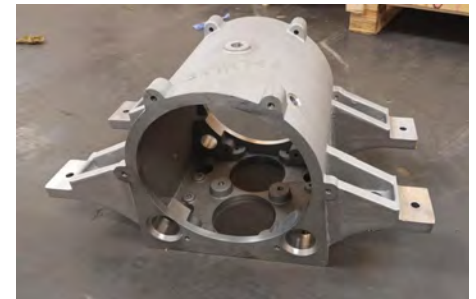
It was extremely challenging to achieve the perfect dimensions required by the customer as the original casing had been damaged, badly repaired, and distorted several times. As the part was made over 100 years ago and no specifications existed, NovaCast's engineers worked to general engineering tolerance i.e.  $\pm 0.25\text{mm}$  and  $\pm 0.5\text{mm}$  machining tolerance. Casting tolerance was based on BS EN ISO 8062 CT12 and the crank case was manufactured in LM25TF, the heat treated form of LM25 aluminium alloy.

The new crankcase was cast in aluminium, heat treated and machined to the original specifications.
